THAMES RIVER BASIN
WINDHAM, CONNECTICUT
BIG POND DAM
CT 00194

PHASE I INSPECTION REPORT
NATIONAL DAM INSPECTION PROGRAM

DEPARTMENT OF THE ARMY
NEW ENGLAND DIVISION, CORPS OF ENGINEERS
WALTHAM, MASS. 02154

AUGUST 1980

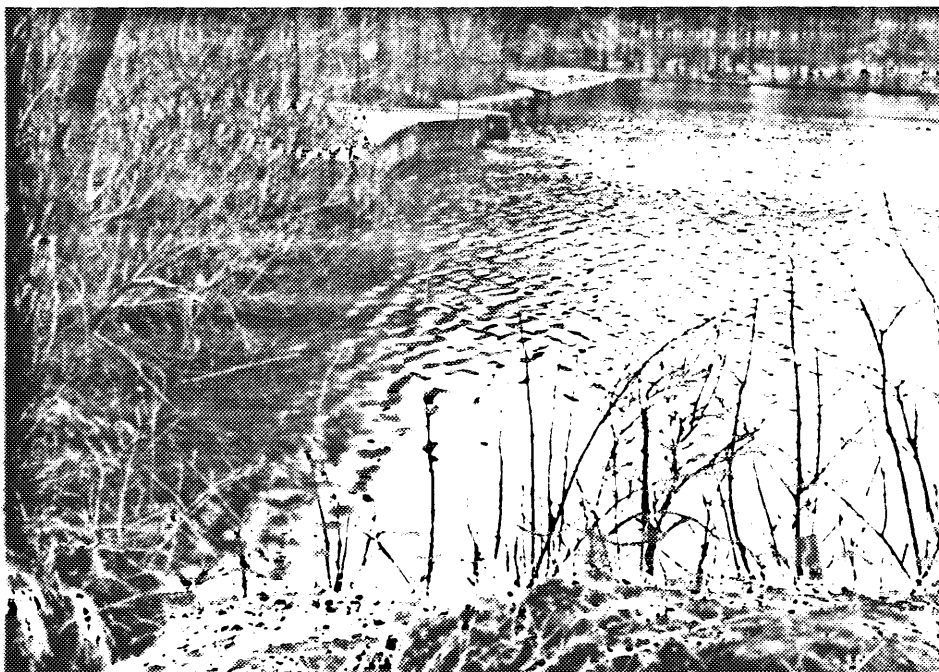
Upstream Slope - The upstream slope is the vertical face of several sections of concrete wall and a small riprapped section at the left end of the dam (Photos 1 and 2). The older section of concrete wall at the right end of the dam is severely spalled and deteriorated, with large cracks and exposed aggregate (Photo 2). The slope at the left end of the embankment has some missing riprap and exposed areas. The newer section of wall appears to be in good condition (Photo 1). The top of the concrete walls are 2-3 feet below the top of dam. The riprapped slope below the waterline could not be inspected.

Photo 1 - Upstream slope from left abutment. Spillway at upper center and outlet mechanism to right of spillway. (April, 1980)

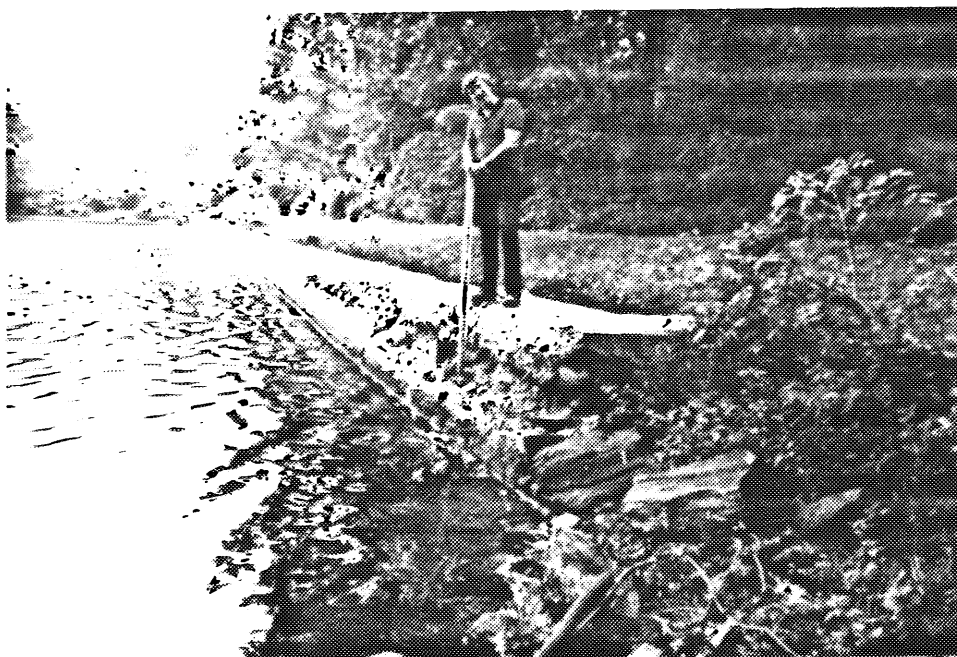
Auxiliary Spillway - The weir for this spillway is a low swale with a grass and weed cover. The small earth dike at the left side of the spillway channel has a grass cover and brush on the slopes. The hand-laid riprap on the floor of the spillway channel is overgrown with brush and small trees. There are no training walls for this spillway except for a small section of concrete at the left end of the spillway. This concrete is severely spalled and deteriorated (Photo 2).

Photo 2 - Upstream slope from right abutment. Left training wall for auxiliary spillway at right. (April, 1980)

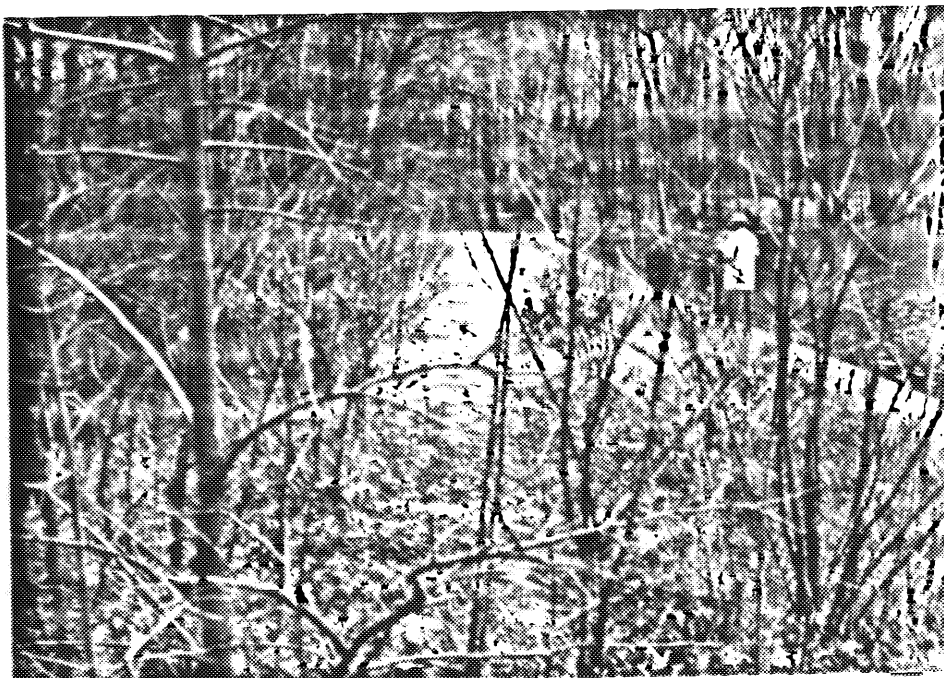
Crest - The crest of the dam is covered with grass, weeds and brush and is very uneven. An area eroded by trespassing was noted on the downstream side of the crest and directly above the outlet conduit. (See photo 4)

Photo 3 - Crest of dam from right spillway training wall. (April, 1980)

4. Downstream masonry retaining wall repair.
5. Filling of erosion and grading the top of the dam.
6. Seepage rate monitoring with lake level readings as recommended by the engineer in Section 7.2. Any changes in seepage not corresponding to changes in lake level should be analyzed immediately by a qualified engineer.

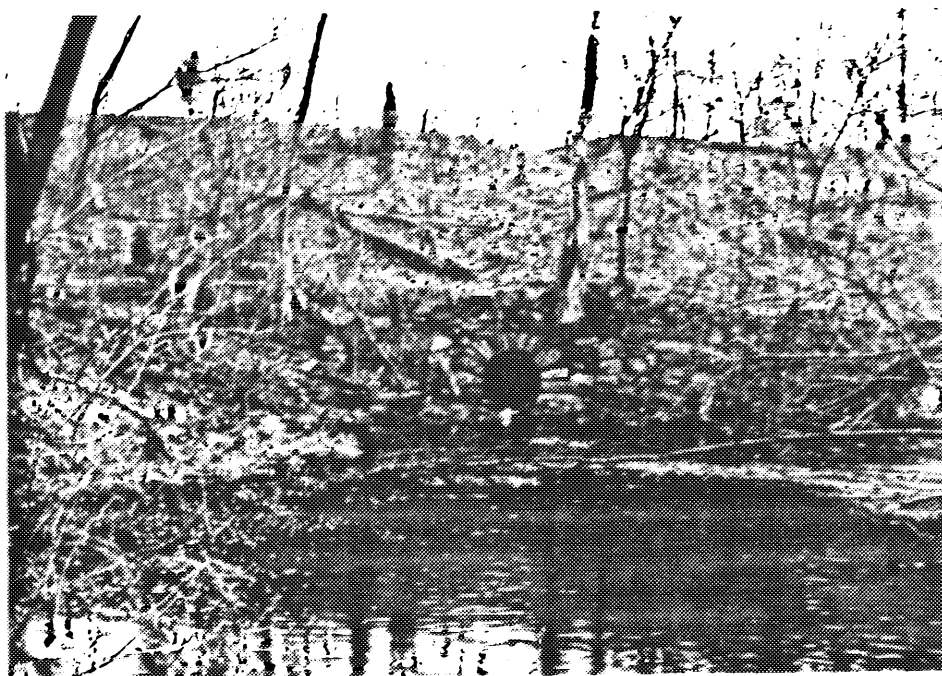
Downstream Slope - The downstream slope is covered with large trees and brush. The alignment of the dry-laid stone retaining wall at the center of the dam appears good, but the wall needs repair and there are some trees and brush growing out between the stones (Photo 4). Three seeps of 2-5 gpm were observed at the central portion and right end of the toe of the embankment (Photo 6). Several more large seeps were noted at the toe of the slope near the outlet conduit and at the left end of the dam (See sheet B-1). The water emanating from all seeps was clear at the time of the inspections.

Photo 4 - Downstream slope, dry-laid stone retaining wall and low-level outlet conduit. (April, 1980)

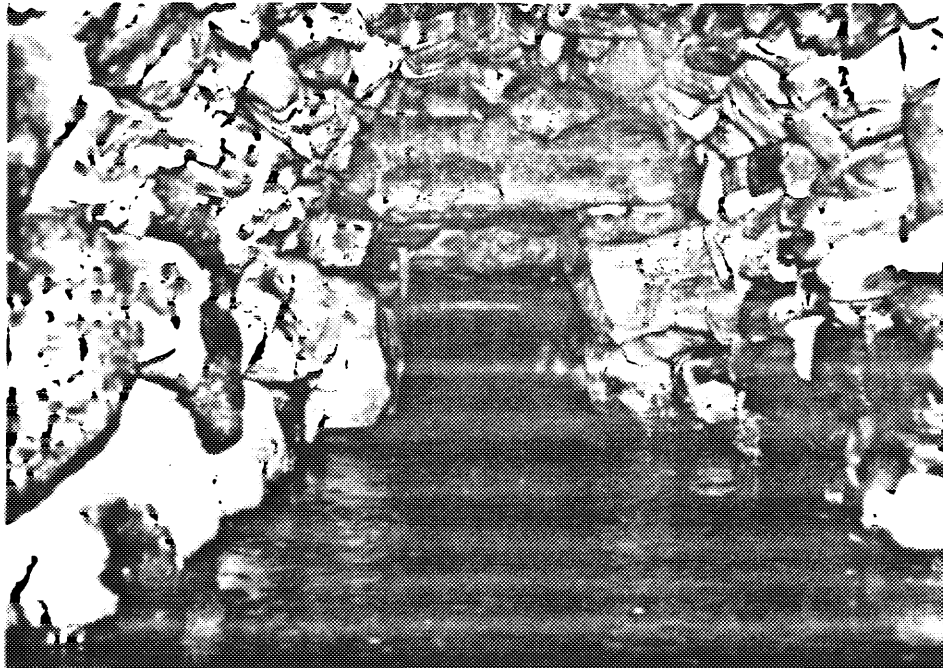
Photo 5 - Low-level stone outlet conduit from downstream.
(April, 1980)

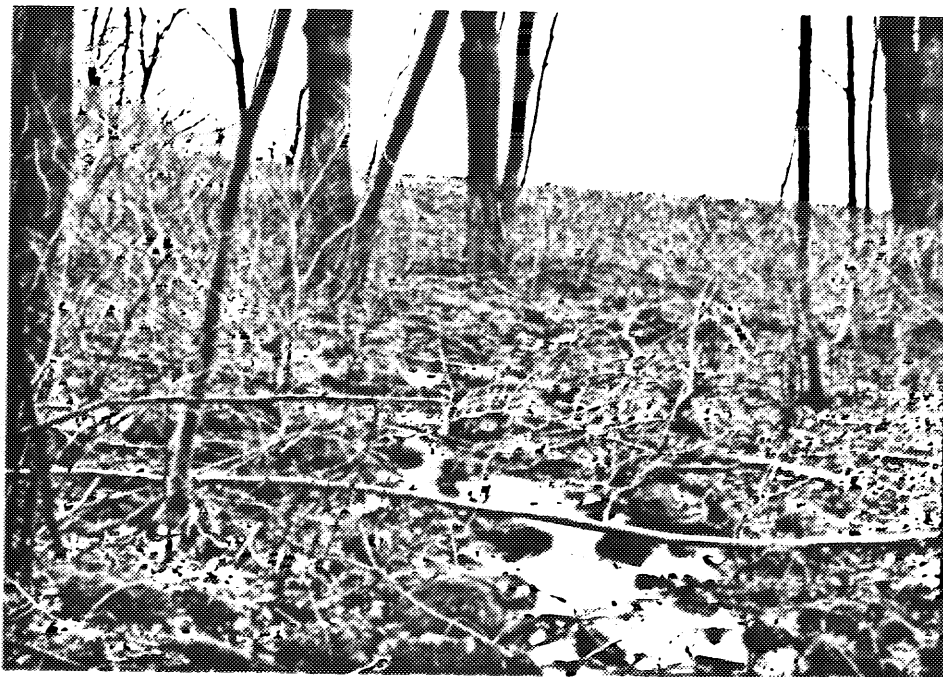
Photo 6 - Seepage stream from the toe of the embankment
at the right end of the dam. (April, 1980)

1. Origin and significance of all seepage sources at the principal spillway and along the toe of the embankment should be investigated immediately upon the owner's receipt of this report. A program for flow meter installation and frequency of readings should be developed.
2. A more detailed hydraulic/hydrologic analysis to determine the adequacy of the existing project discharge and overtopping potential.
3. Inspection of the low-level outlet to determine the condition of the sluice gate and the internal condition of the conduit. This inspection would probably include implementation of a diving program.
4. Boring program development to establish the condition of the embankment and dam foundation. This program should include soil sampling and piezometer installation.

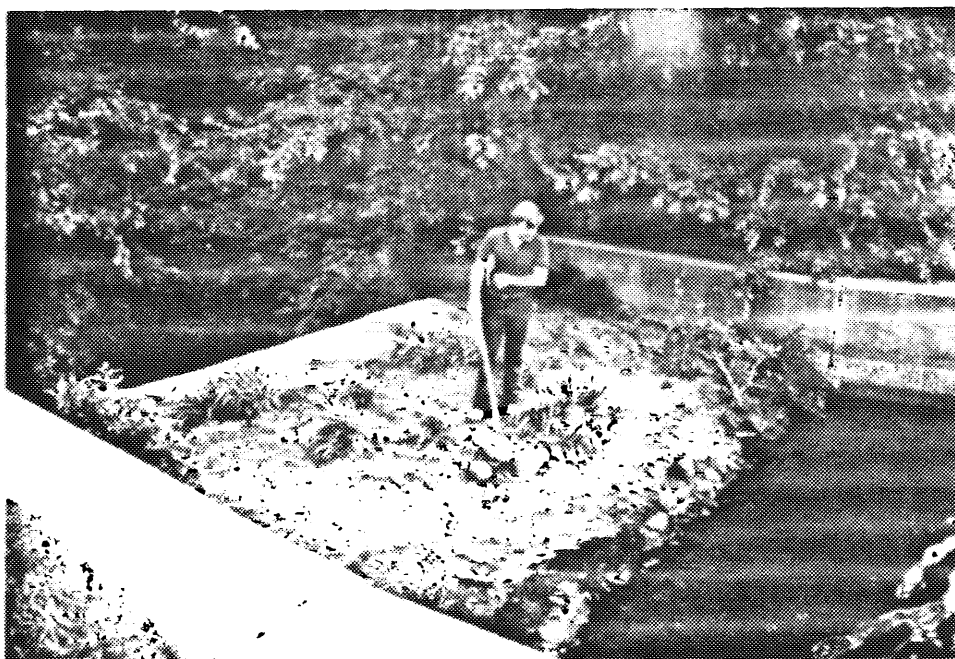
Principal Spillway - This spillway is in poor condition. There is undermining of the concrete training walls as well as some cracking of the concrete (Photos 7 and 9). The riprap protection on the approach channel and crest of the spillway has been removed (Photo 7). The dry-laid stone training walls at the downstream side of the spillway have brush and small trees growing between the stones, displacing some of the stone. The discharge channel has several large holes in the stone paving and is overgrown with trees and brush (Photo 8). There was seepage emanating from under the stone paving although there was no water flowing over the spillway during the July, 1980 inspection (Photo 10).

Photo 7 - Principal spillway from left training wall
(July 1980).

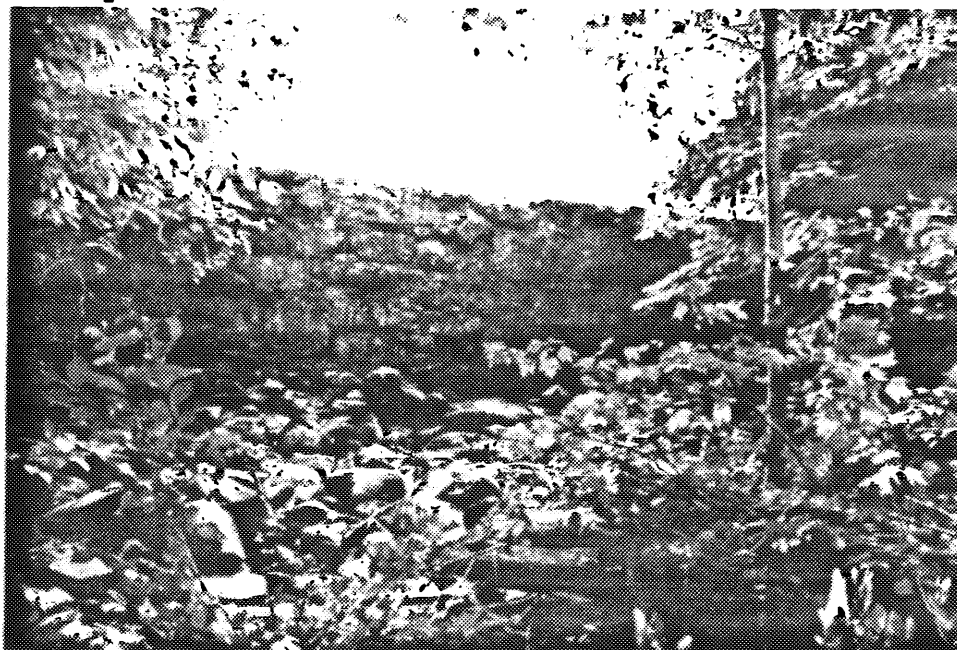
Photo 8 - Principal spillway from discharge channel
(July 1980).

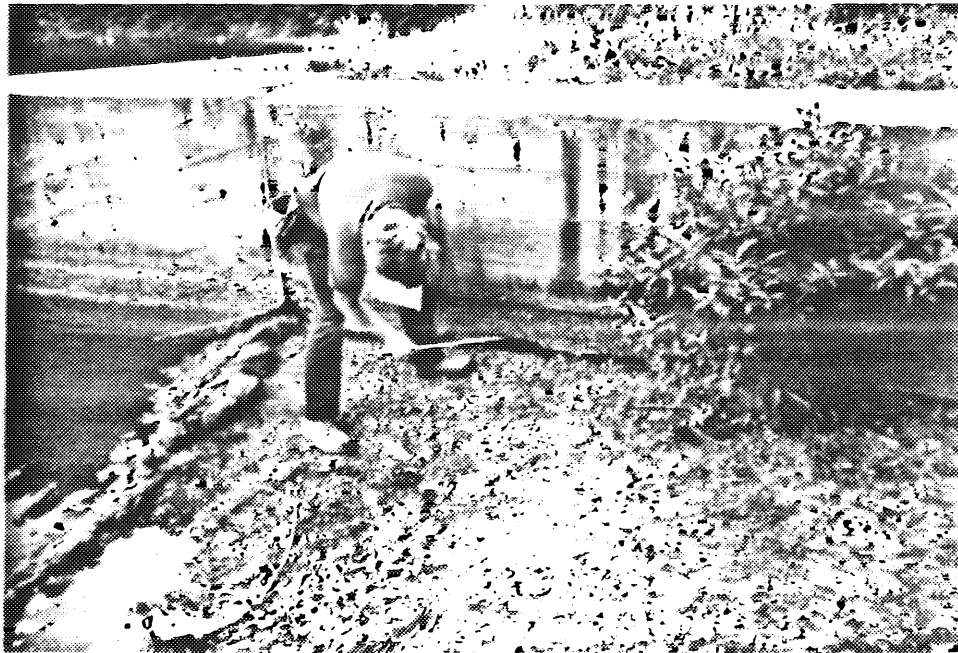
Photo 9 - Undermining of spillway training walls (July 1980).

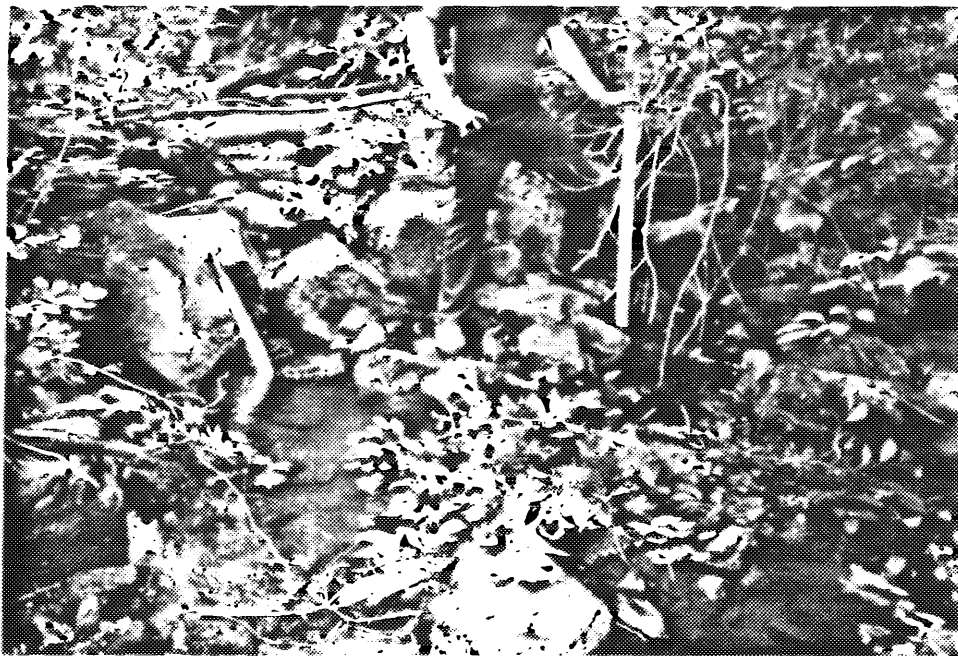
Photo 10 - Seepage emanating through downstream face of spillway weir and under channel lining (July 1980).
